# TEST REPORT

| <p>1. Report No : DRCKREL2510-0348</p> <p>2. Customer</p> <ul style="list-style-type: none"> <li>• Name : VIONS INC.</li> <li>• Address : 12-35, Seounsaneop-ro 50beon-gil, Gyeyang-gu, Incheon, Republic of Korea</li> </ul> <p>3. Use of Report : For quality control</p> <p>4. Product Name / Model Name : Seismic Support Hanger / VOS-038-001</p> <p>5. Test Method Used : Seismic Test Method for Telecommunication Facilities<br/>(National Radio Research Agency Announcement No. 2022-7)</p> <p>6. Date of Test : September 05, 2025</p> <p>7. Location of Test : <input checked="" type="checkbox"/> Permanent Testing Lab <input type="checkbox"/> On Site Testing<br/>(Address : 28, Baengnyeong-ro, 20Beon-gil, Cheoin-gu, Yongin-si, Gyeonggi-do, Korea)</p> <p>8. Testing Environment : Temperature (25.0 ± 3.0) °C , Humidity (62.0 ± 3.0) % R.H.</p> <p>9. Test Result : Refer to the attached Document</p> <p>The results shown in this test report refer only to the sample(s) tested unless otherwise stated.<br/>This laboratory is not accredited for the test results marked. * * *</p> | | |

The excitation test was performed for "Seismic Support Hanger" in accordance with "National Radio Researc

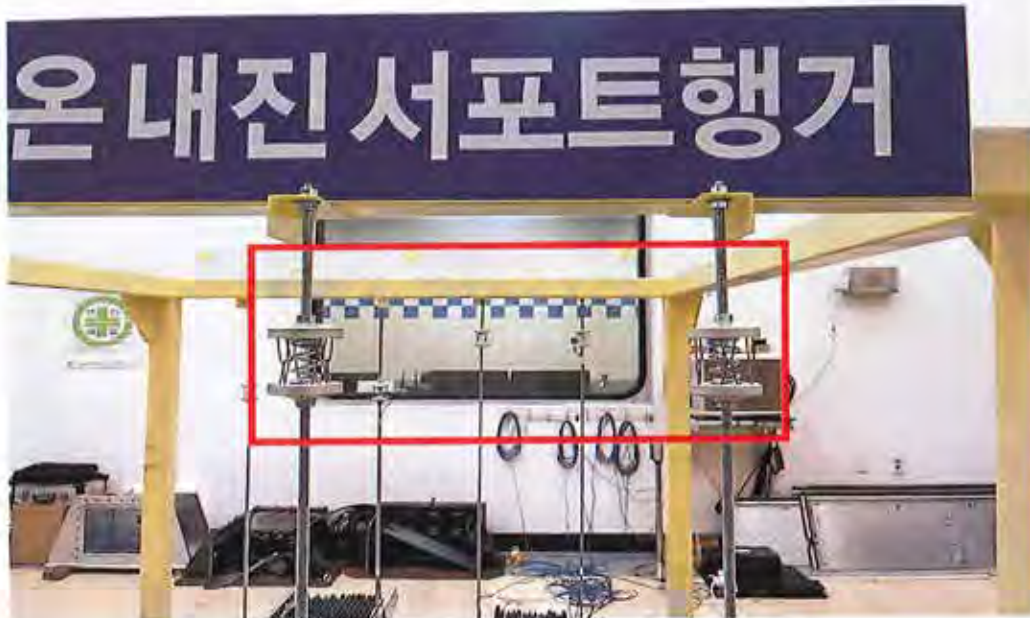
[Figure 1] Seismic Support Hanger – VOS-038-001

The description and figure of the specimen are shown in "Table 1" and "Figure 1". The size and weight of specimen is visual check and record.

| Description | Specification |
|---|---|
| Size | (W) 54.51 mm x (D) 54.51 mm x (H) 72.43 mm |
| Weight | Seismic Support Hanger (4 ea) : 0.67 kg<br>Fixture : 172 kg<br>Cable Tray (1/2) + Dummy : 105 kg<br>Total : 277.67 kg |

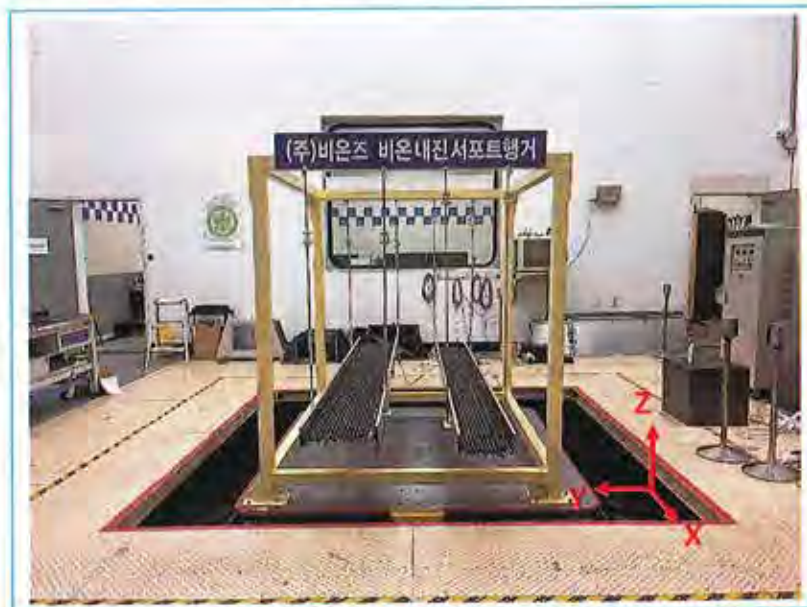
[Figure 3] Seismic Test Setup

The specimen was fixed in the same manner as "Table 3". Accelerometers were installed on the Table, Fixture, VOS-038-001, Cable Tray. The test setup is shown to "Figure 3"~"Figure 4".

※ Note - X : Front-Back, Y : Side-side, Z : Vertical

| Description | Bolt | Q'ty<br>(EA) | Torque<br>(kgf-cm) |
|---|---|---|---|
| Table - Fixture | M12 Bolt | 8 | 770 |

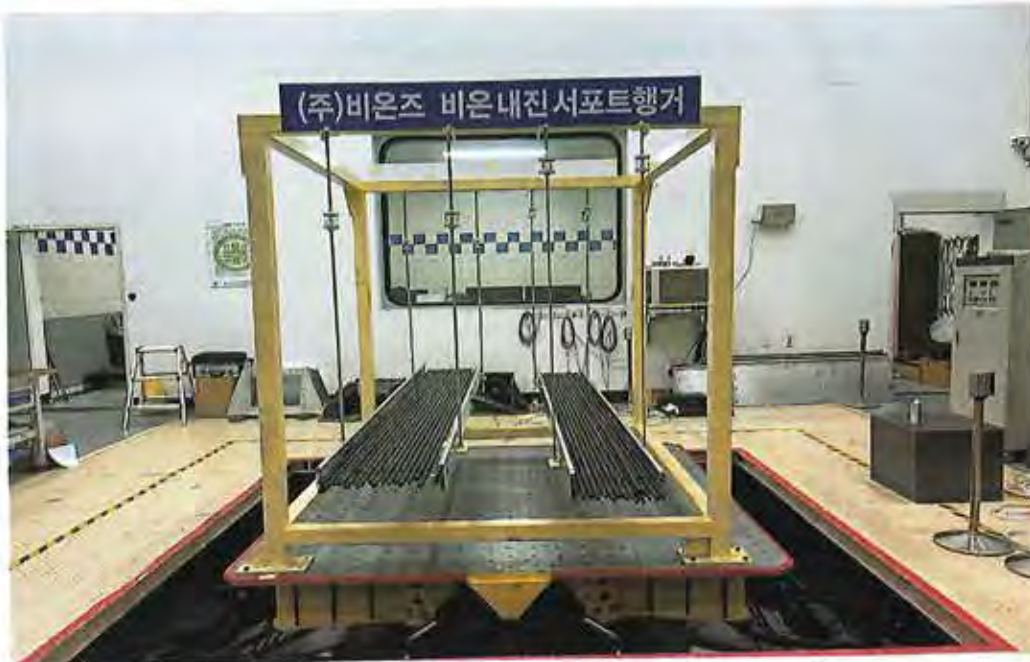
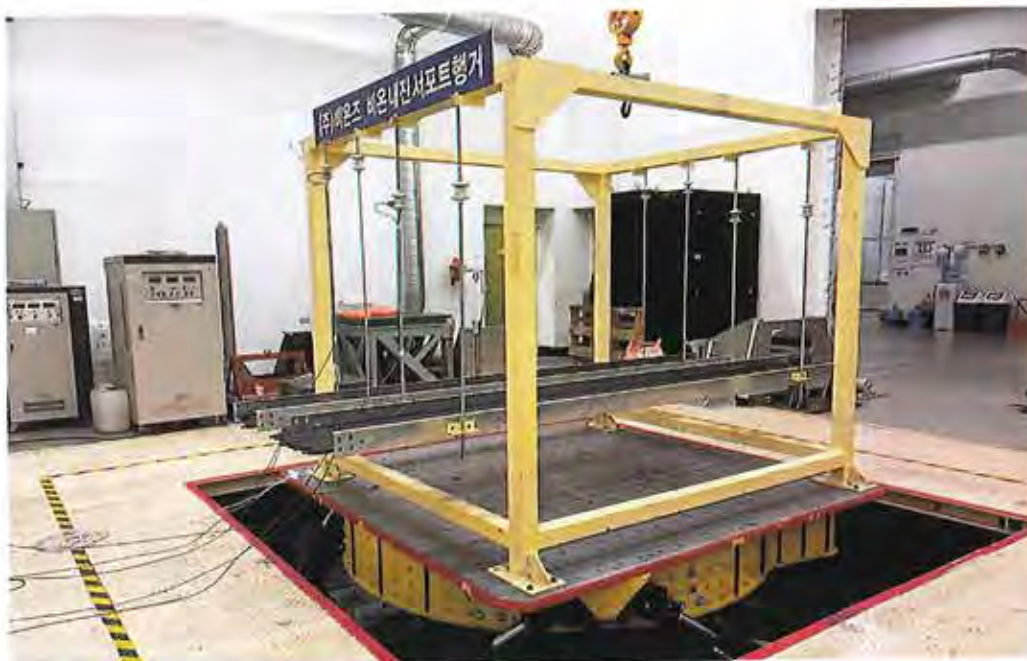
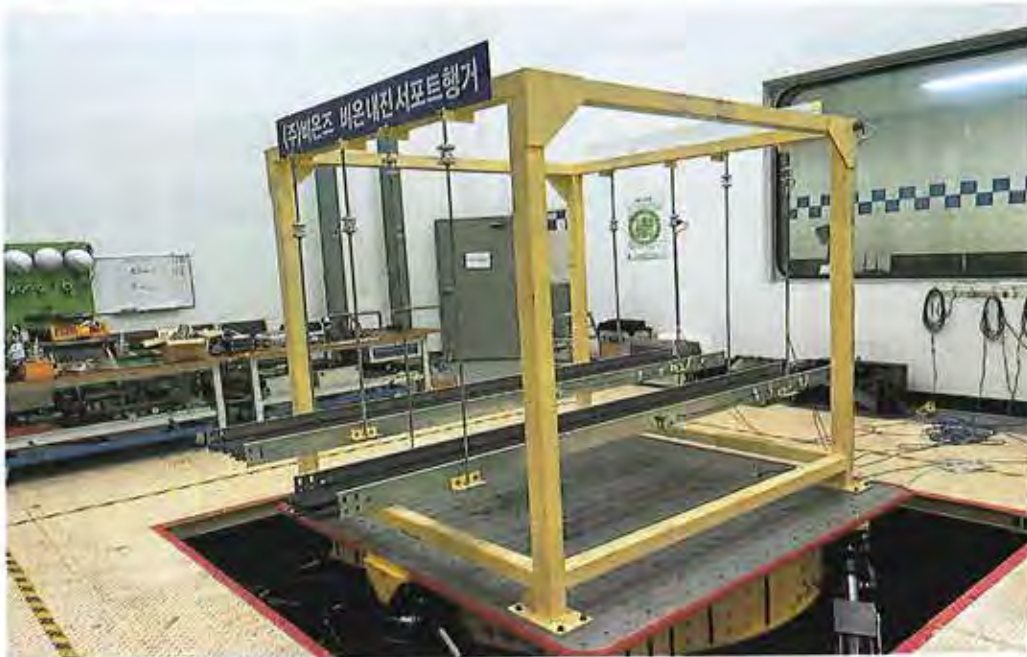
[Figure 4-1] Excitation Test Set up #1

[Figure 4-2] Excitation Test Set up #2

[Figure 4-3] Excitation Test Set up #3

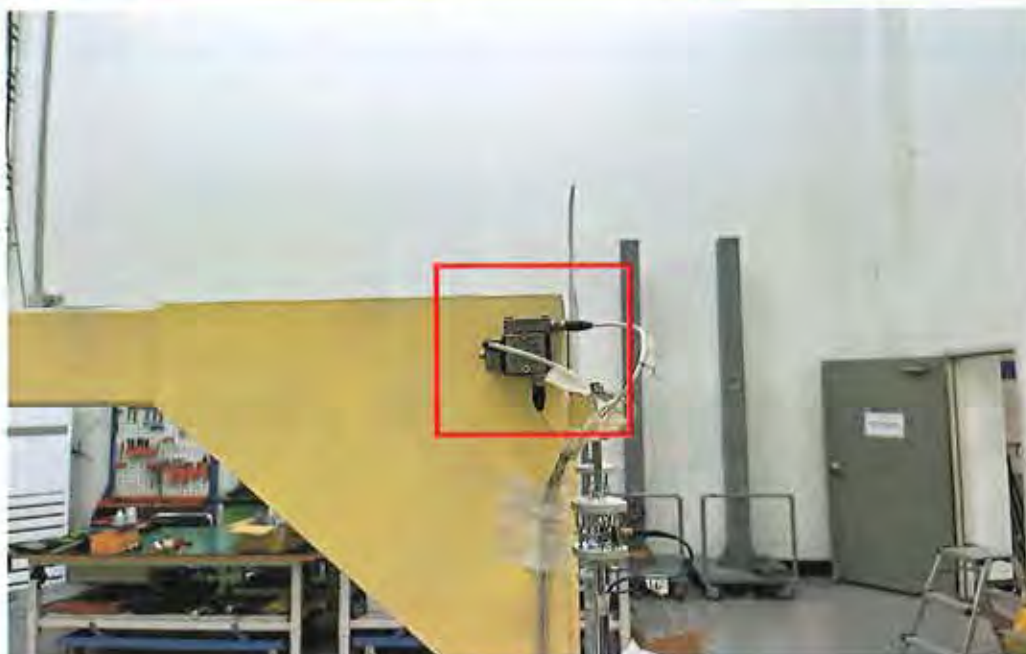
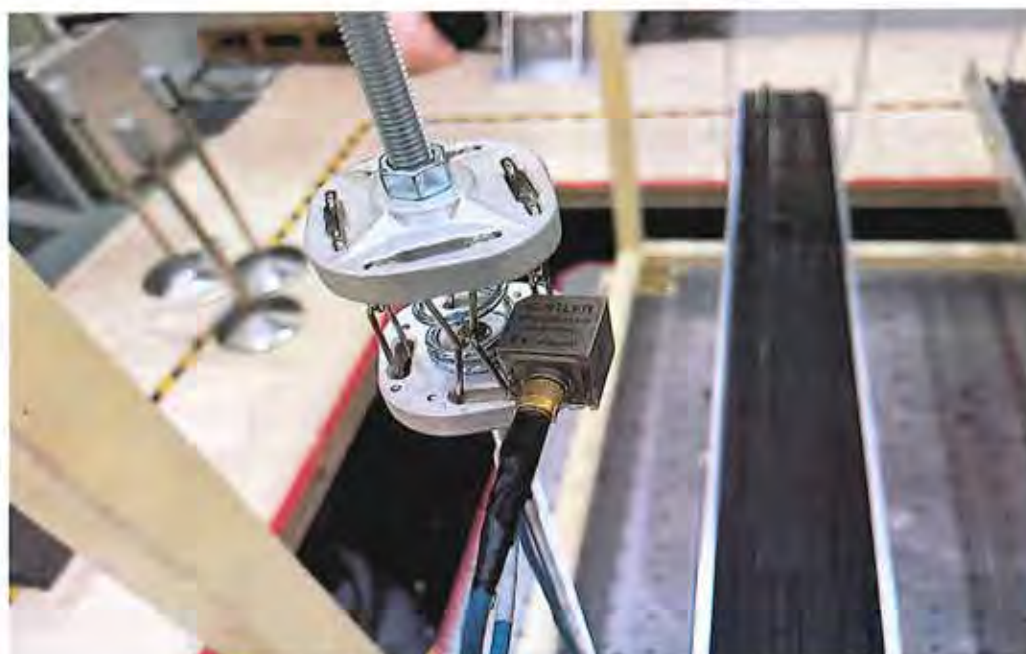
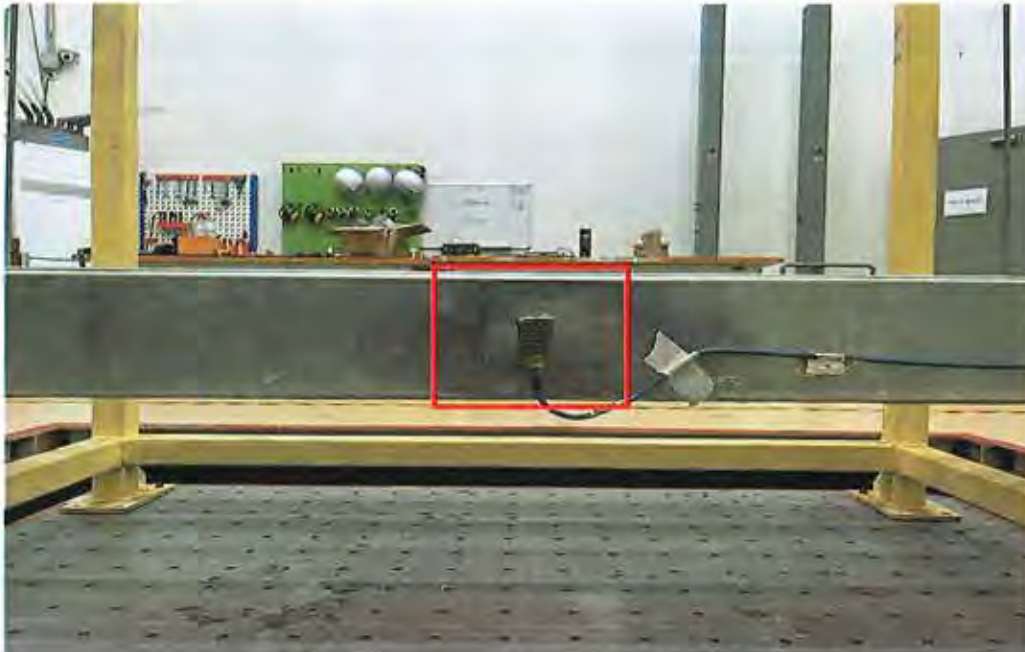
[Figure 4-6] Accelerometer Set up – Table

[Figure 4-7] Accelerometer Set up – Fixture

[Figure 4-8] Accelerometer Set up – VOS-038-001

[Figure 4-9] Accelerometer Set up – Cable Tray (1/2)
